HURON-KINLOSS COMMUNITY SEPTIC INSPECTION PROGRAM

Report on the first round of inspections for the Huron-Kinloss Community Septic Inspection program

TOWNSHIP OF HURON-KINLOSS

CYCLE 1 REPORT

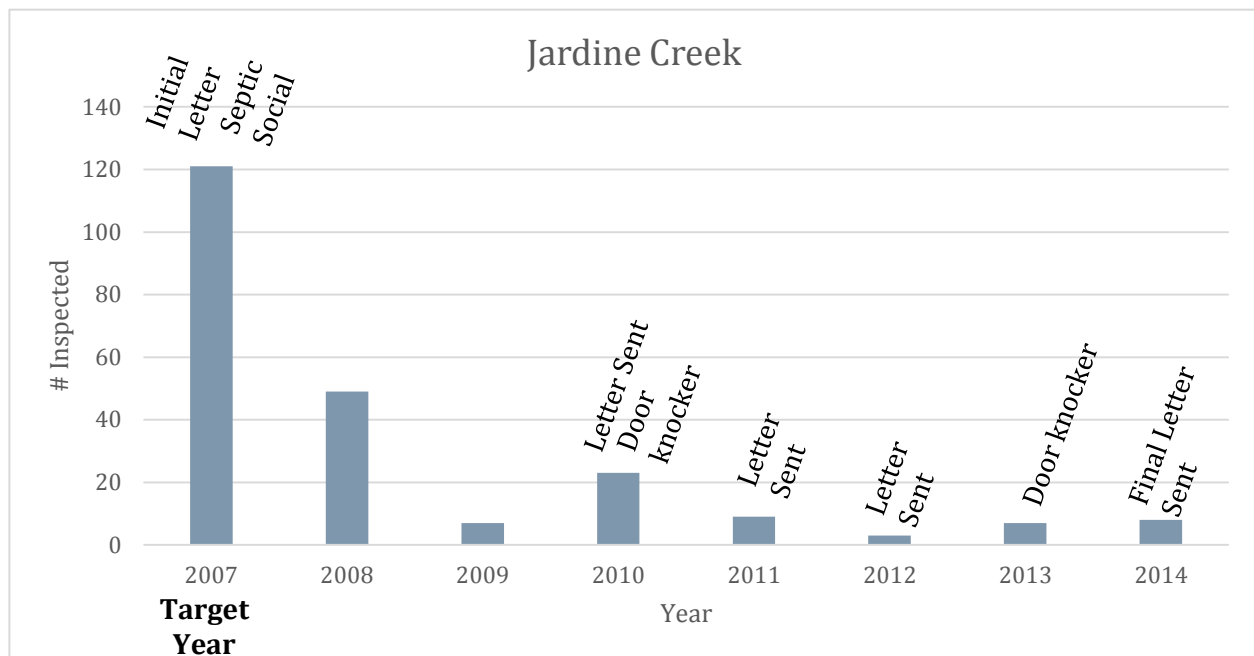
The number of inspections in the target area between 2007 and 2014 are shown in the figure below. Points and methods of contact are indicated on the figure. Following the initial letter for the target area, a septic social was held at the cottage of the local beach association president. The event was well attended. Approximately half (53%) of the properties requiring an inspection in the target area were inspected in the first year. A further 21% were inspected in the following year without any contact. A reminder letter and door knocking efforts in 2010 encouraged another 23 residents (10%) to participate. The remaining 12% required additional contact to participate.

The uptake of the program in Jardine Creek shows the impact of a septic social in influencing behaviours. The septic social was well attended, especially by members of the local beach association. It was also aided by hosting the social at the home of a well-known and well-respected member of the local community. This helped spread the benefits of the program throughout the community. Also supporting program participation in this target area was high local awareness of water quality issues.

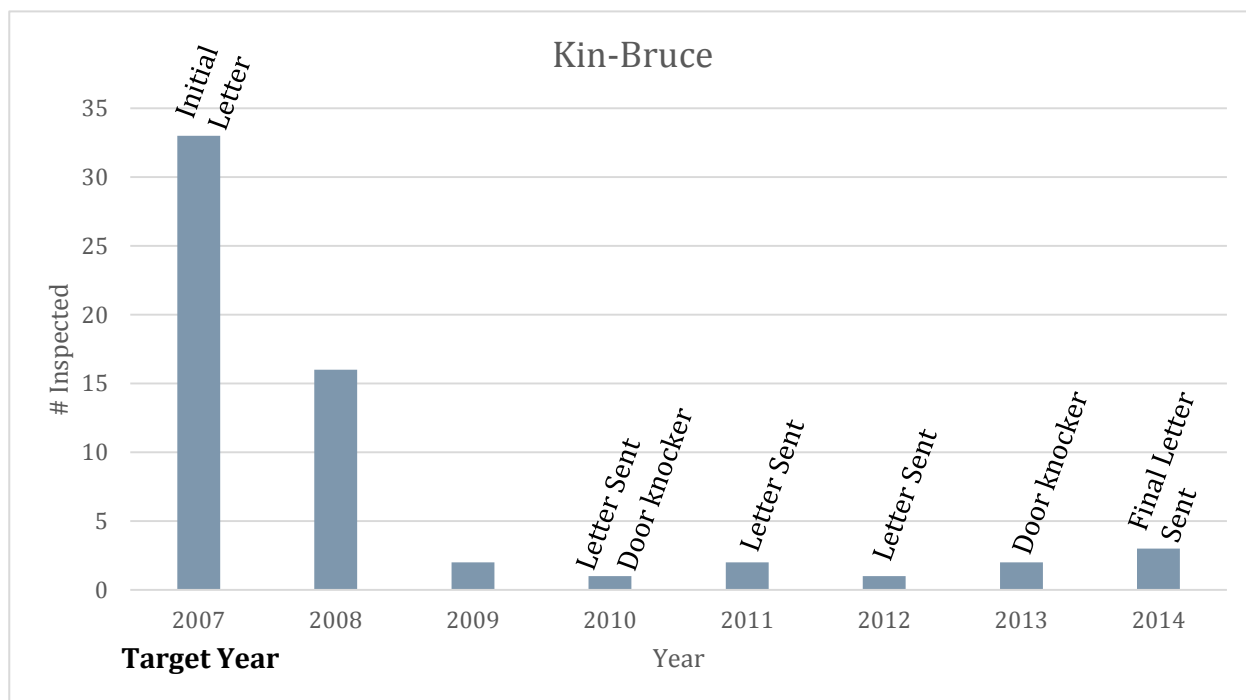
Program uptake, as shown by the number of inspections per year from 2007 to 2014 is shown in the figure below. Similar to Jardine Creek, which was also one of the first target areas, there was a strong initial response to the program in Kin-Bruce. Over half of property owners with septic systems had an inspection completed after receiving an initial letter. In the following year, another 26% of residents participated without further prompting. The remaining 20% of residents (11 property owners) required additional contact and reminders to participate.

This target area did not have a septic social. Given the area is primarily permanent residents, not connected by membership in a local organization, it was thought a septic social would have minimal impact. The small size of the target area (both population and geographically), likely allowed for word of mouth communication to promote the program, as observed by the number of inspections completed in 2008 without receiving any letters or reminders.

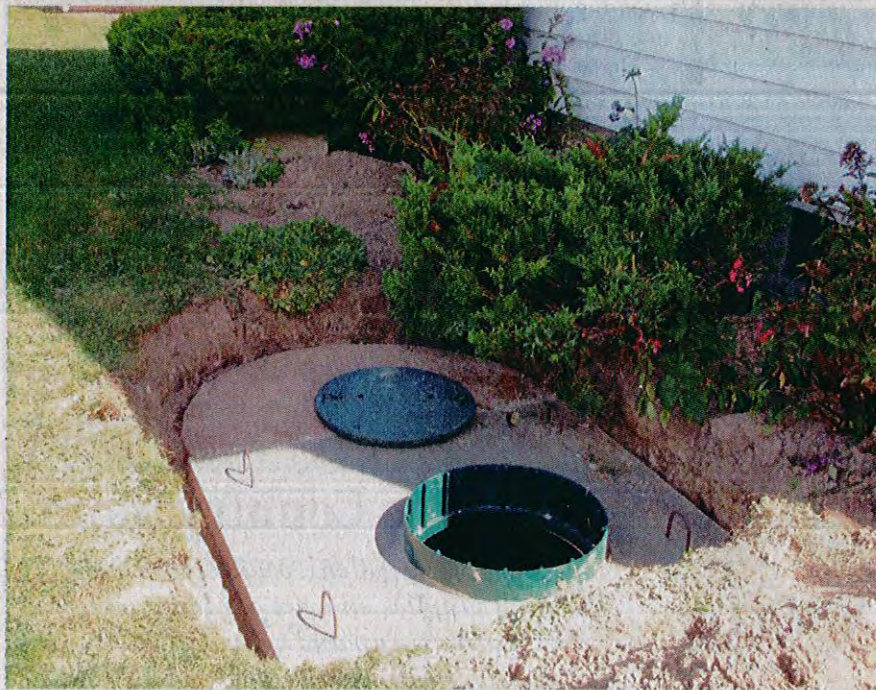
The Lake Huron shoreline, seen from the Point Clark lighthouse, (top) shows the close proximity of cottages and homes, and their septic systems, to the lake. Directly above, a new double chamber septic tank has risers to make it easy to access the tank for pumping and annual cleaning of the filter.

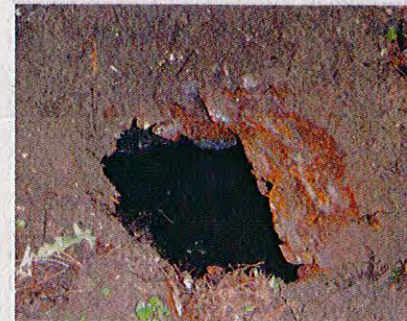
An inspector found this barrel was being used as the septic tank and even the metal lid was corroded.
